Pre-Purchase Inspection - Residential Building Report

Complies with Australian Standard AS 4349.1- 2007 Inspection of Buildings Part 1: Pre-Purchase inspections – Residential buildings – Appendix “C”

Property Address: Your New Home Address

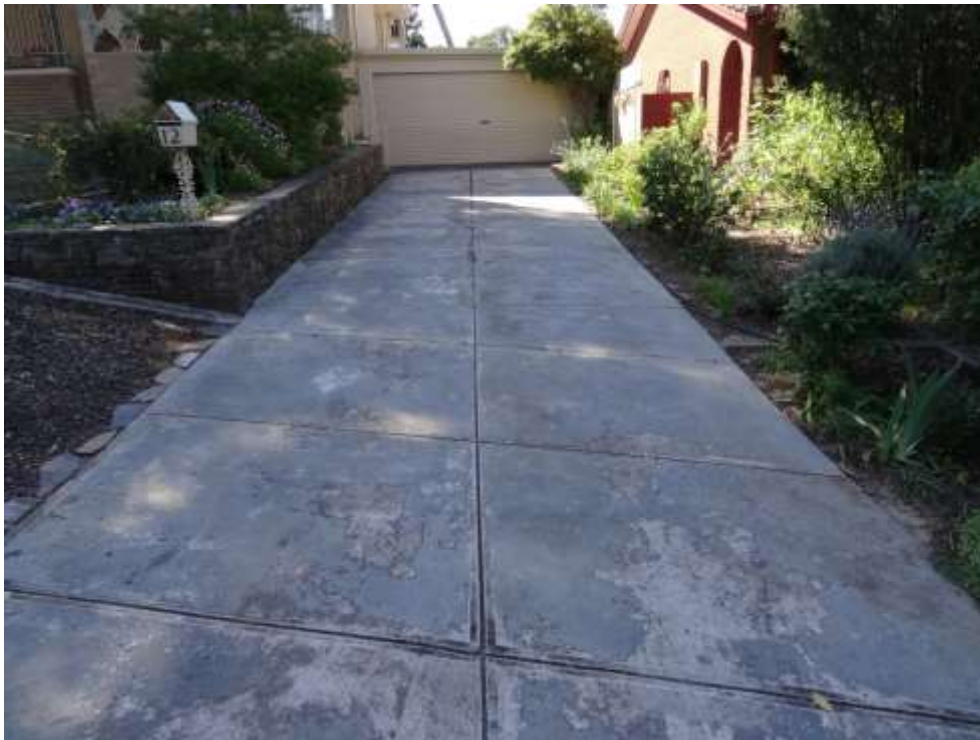
Driveways: No Defects / Safety Hazards found : Minor cracking – Typical

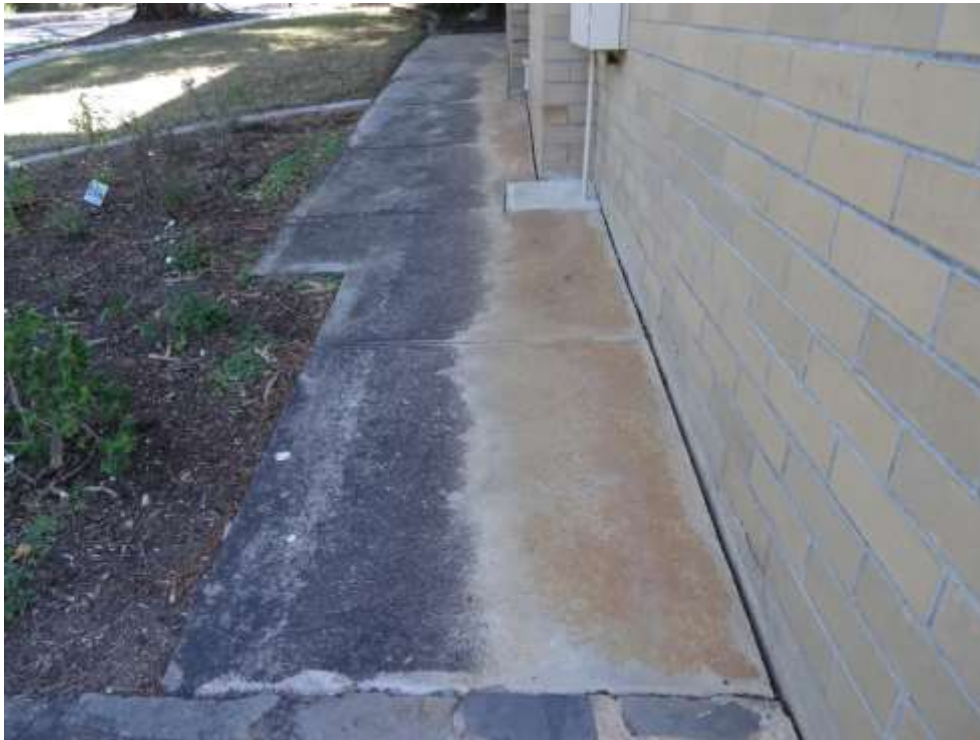
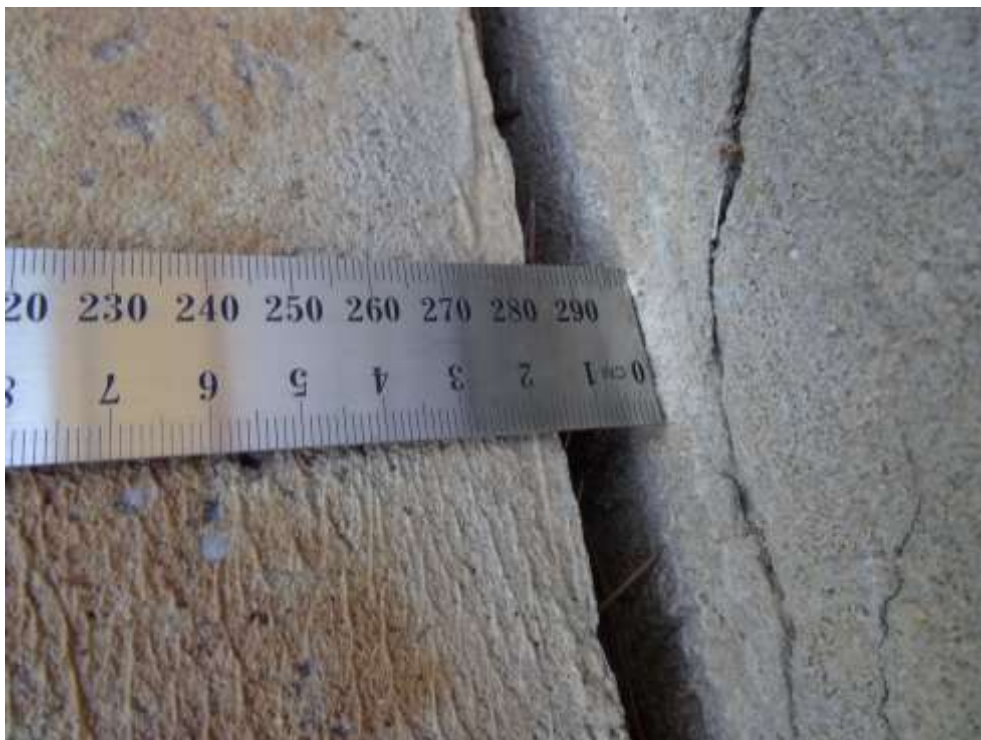
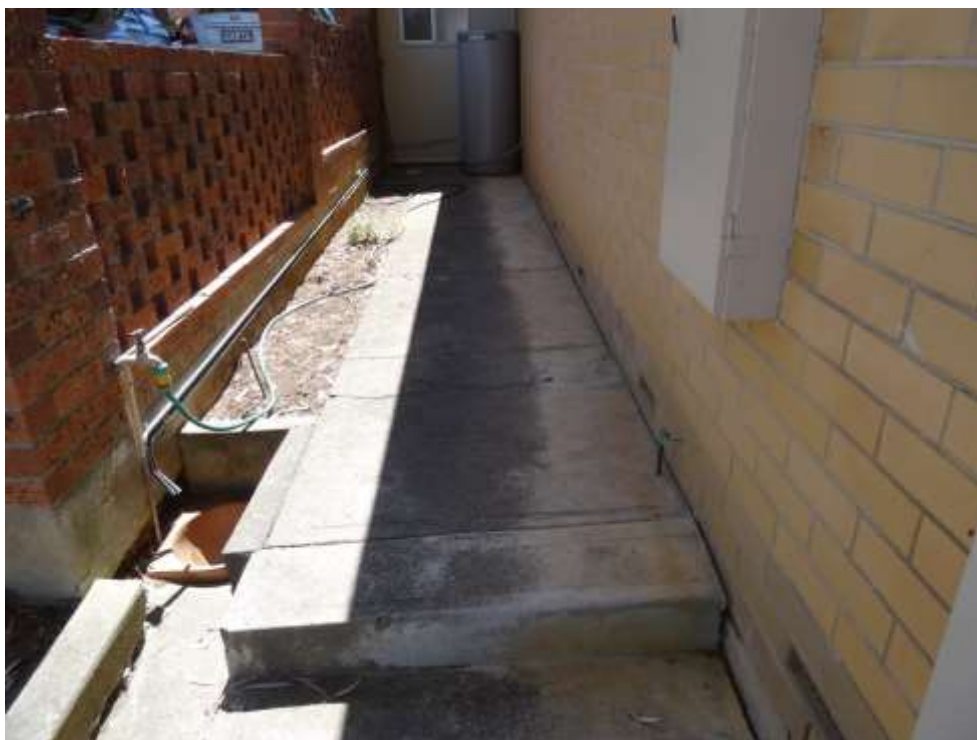
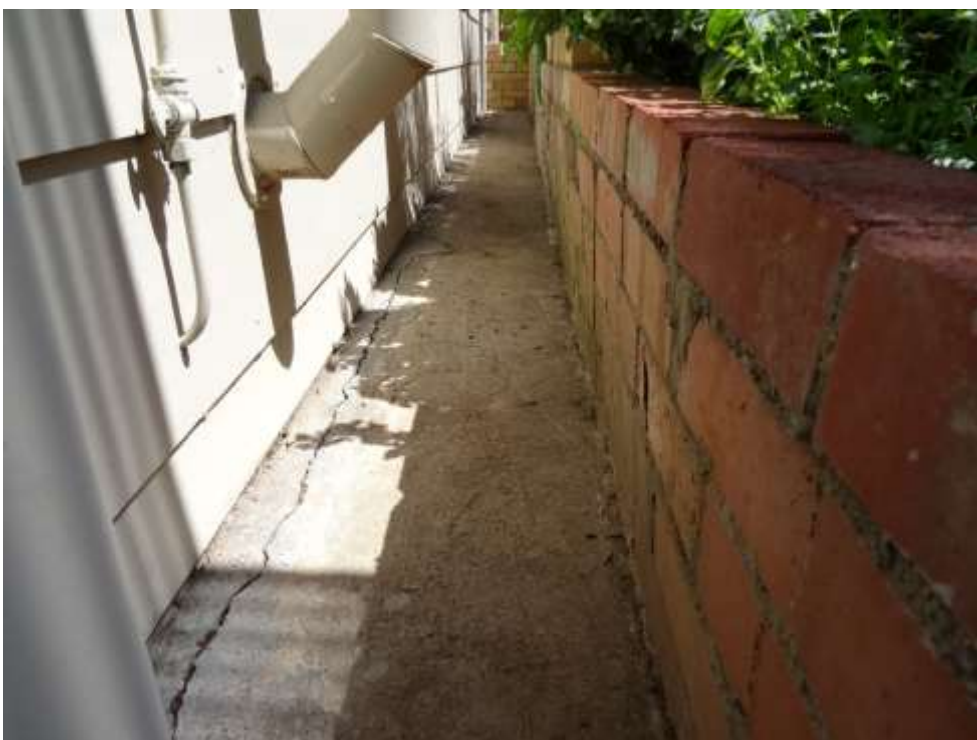
Paths: No Defects / Safety Hazards found : Minor cracking – Typical; Path moved approx. 15mm away from hose at SE corner, Typical for area and soil type.

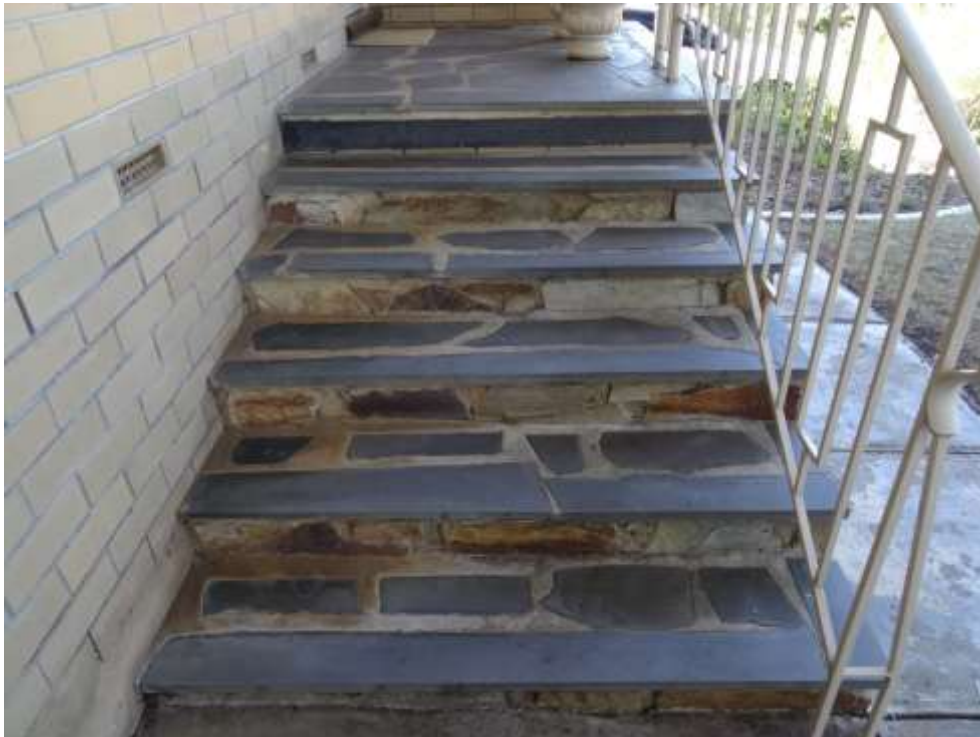
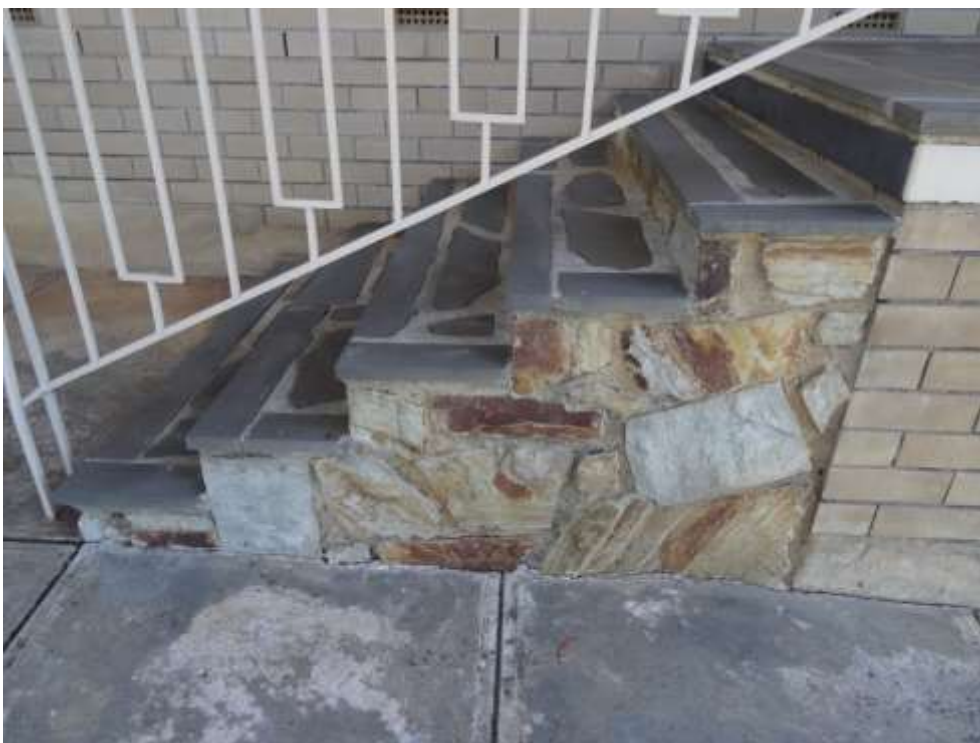
Steps: No Defects / Safety Hazards found : Flagstone steps in solid condition

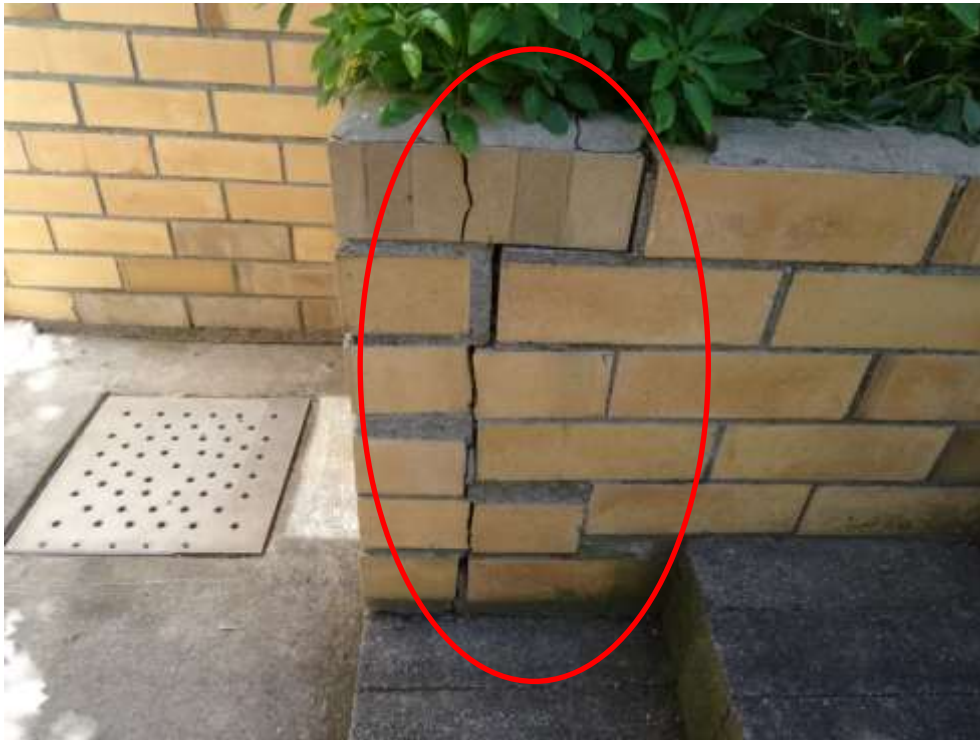
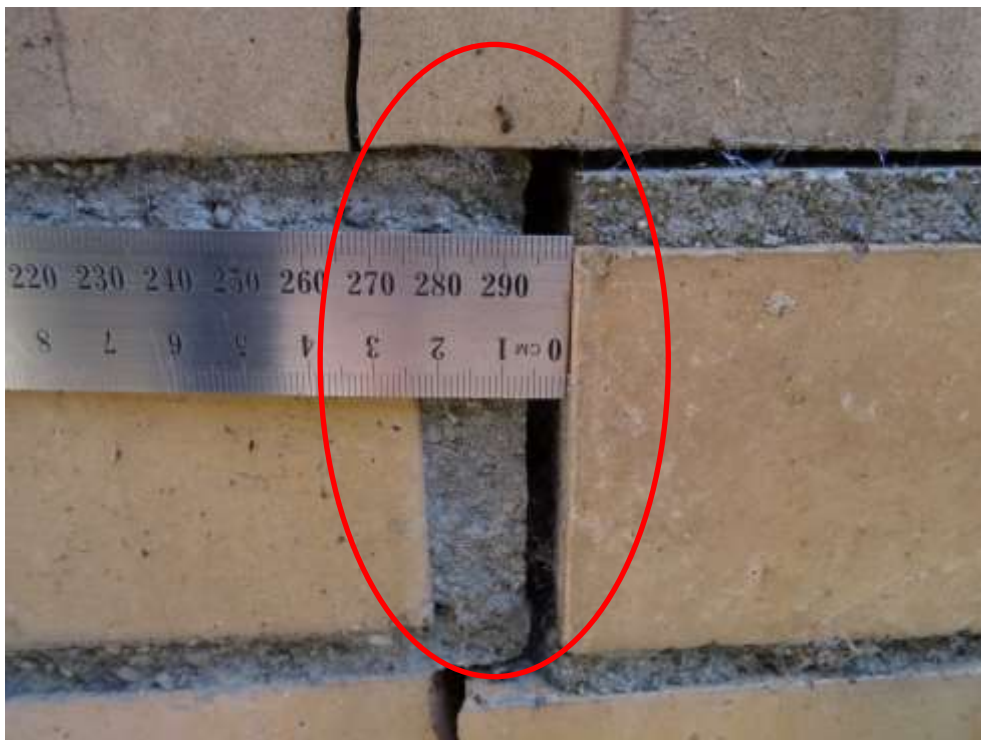
Retaining Walls: Minor Defect / Safety Hazards found : 700mm high retaining wall has crack in corner outside laundry door. Will need attention.

Areas Inspected	Location	Description of the Cracking Defect at the time of the Inspection.
Concrete Slabs		
Suspended Concrete Slabs		
Masonry Walls	Multiple locations	As shown in photos, cracks are 0-2mm most 0-1mm
Piers		
Retaining Walls	NW fence	As detailed in report, 5mm crack in 700mm high wall, photos attached.
Other Areas

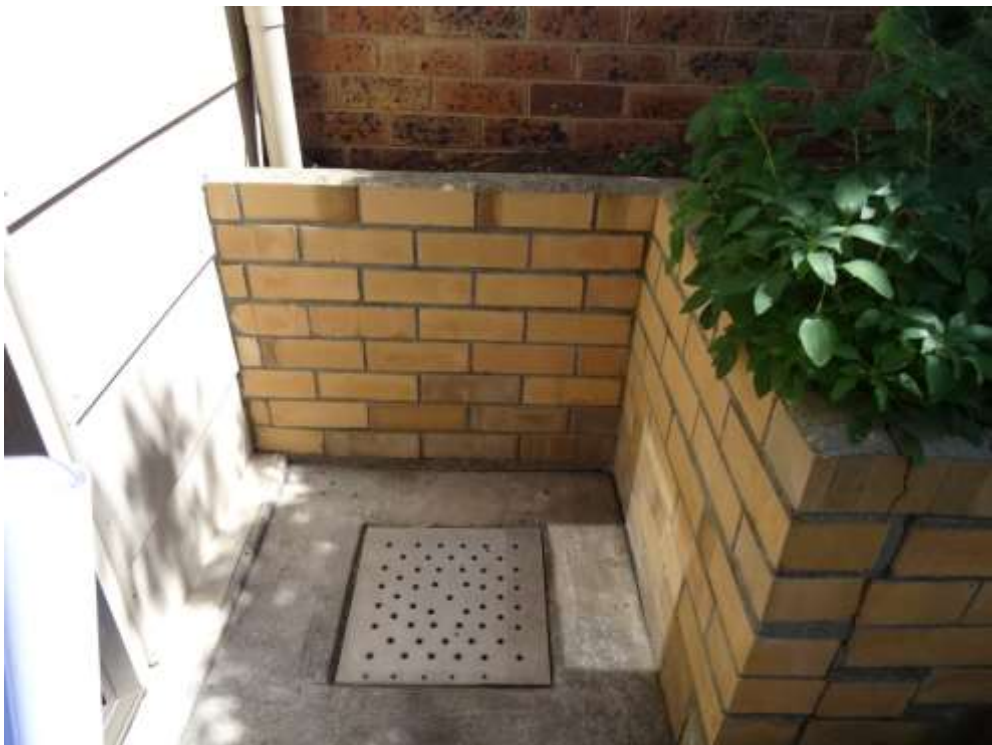
Surface Water Drainage: No Defects / Safety Hazards found : Good Drainage

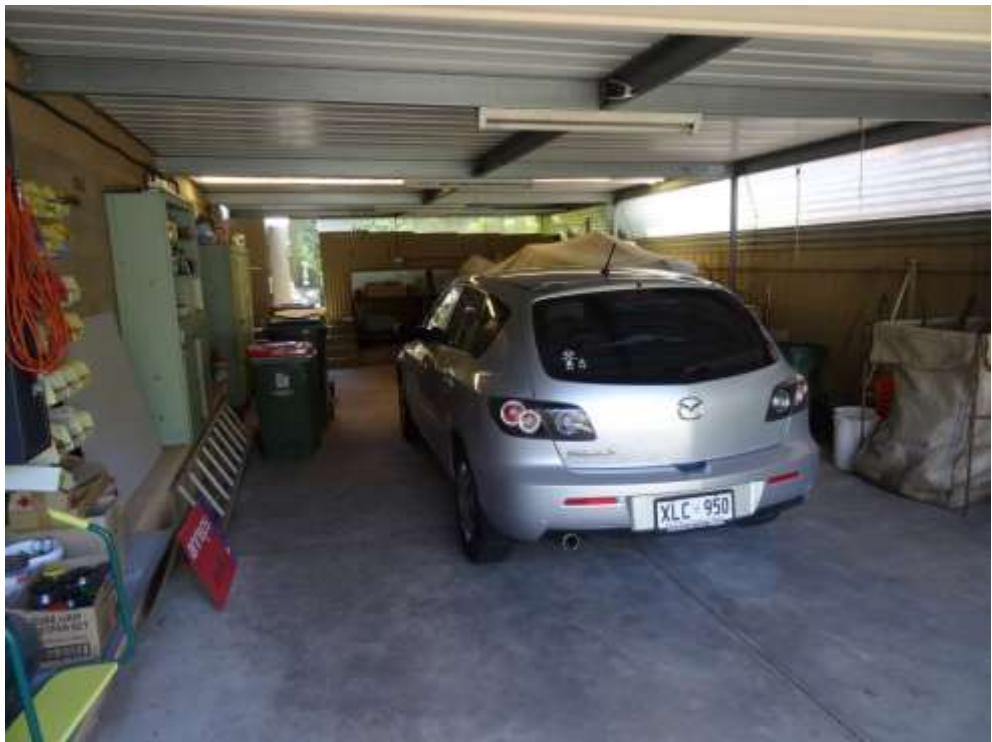
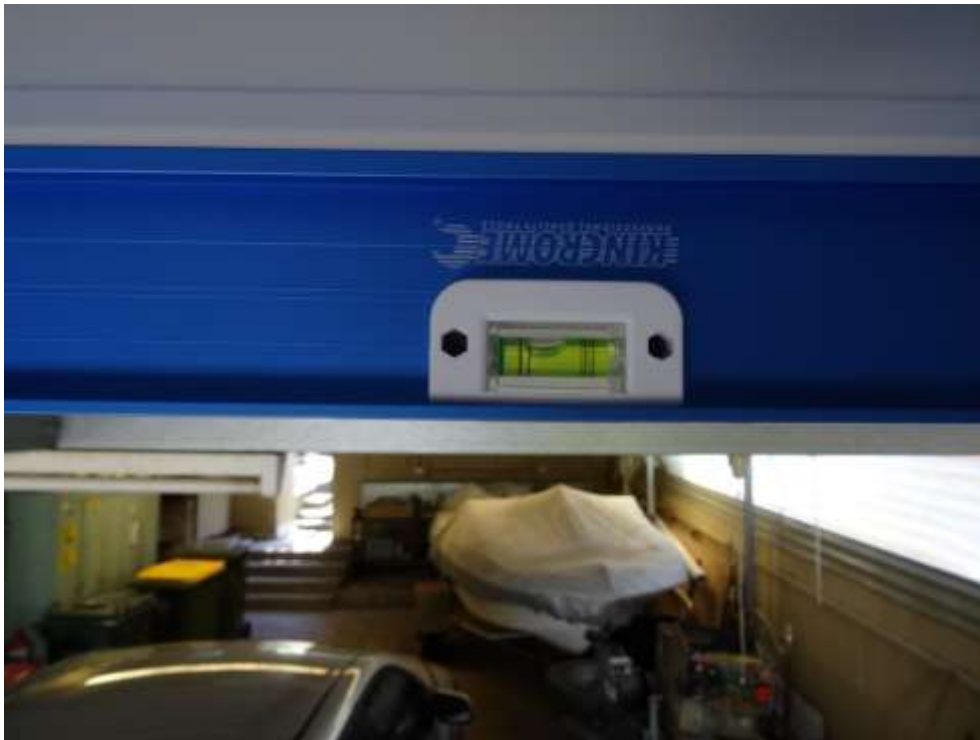
Car Accommodation: No Defects / Safety Hazards found : Good condition, fall on roofing good.

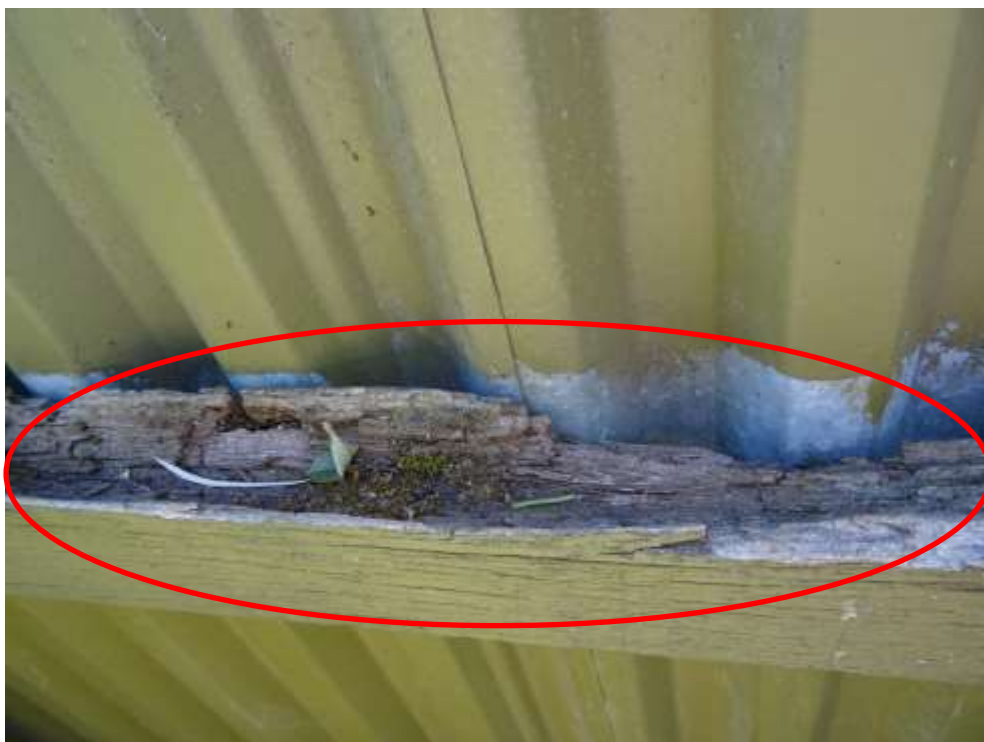
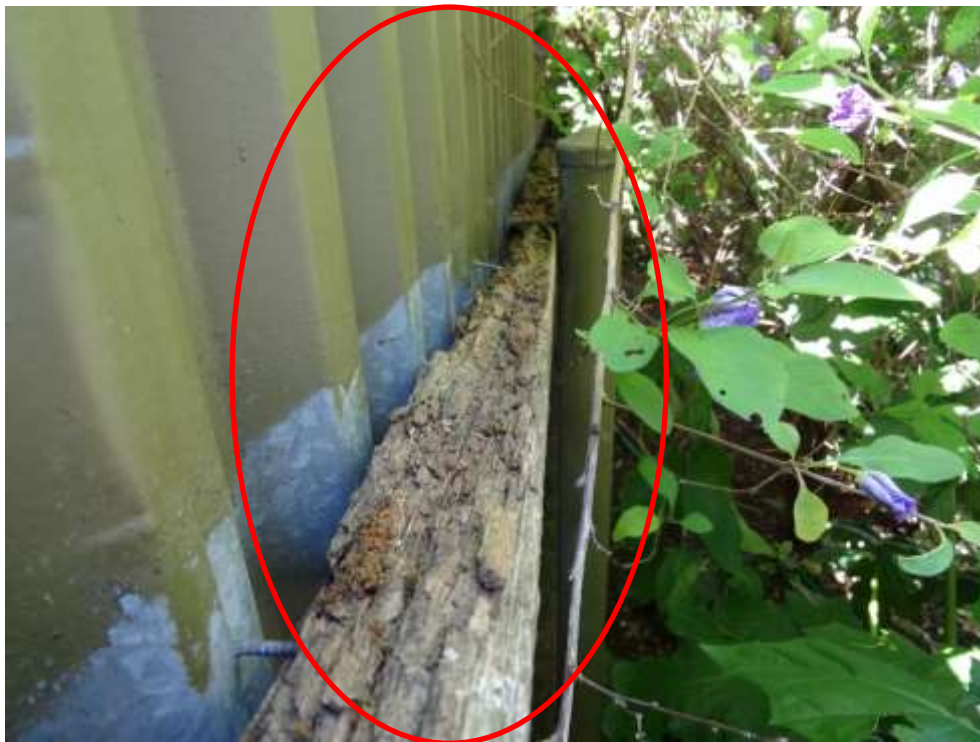
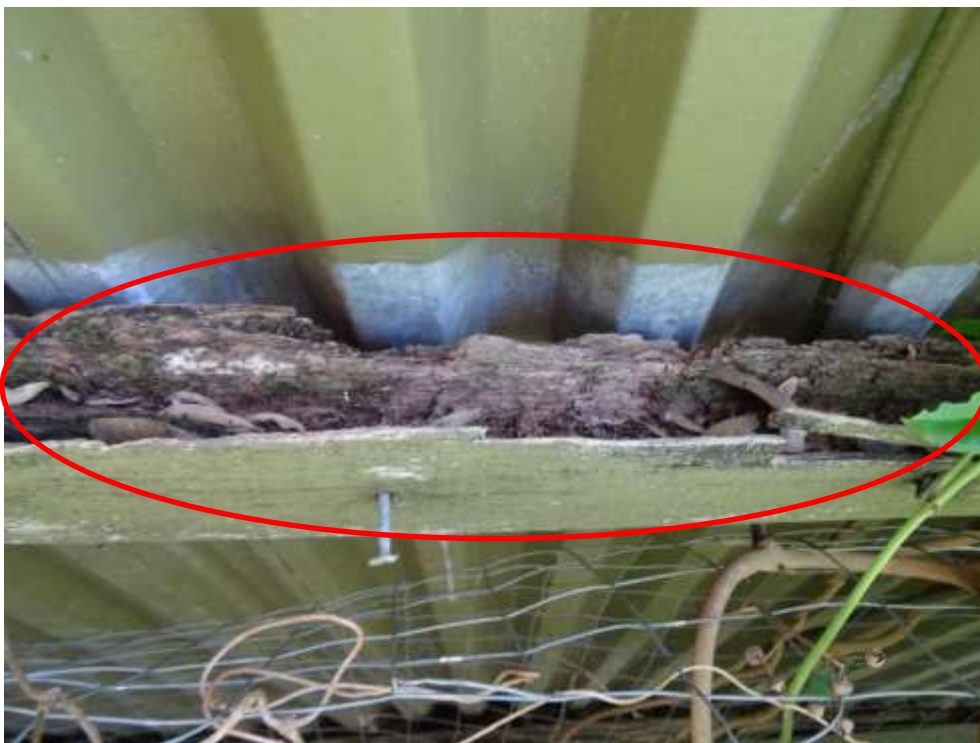
Fences: Minor Defect / Safety Hazards found : Timber rails rotted on back fence, need replacing

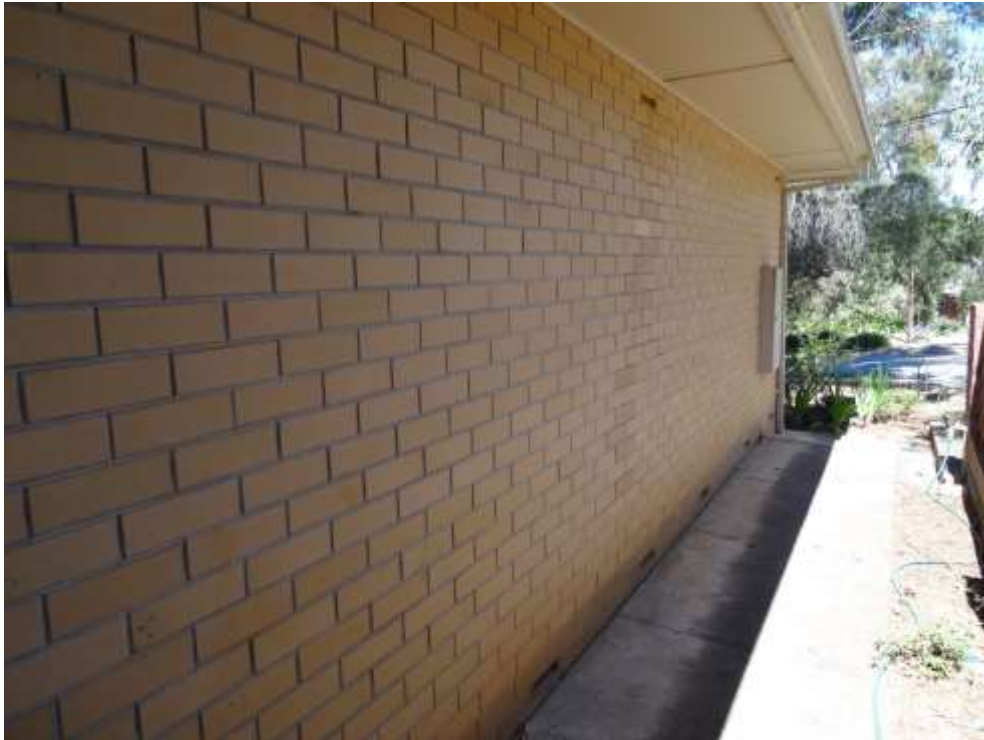
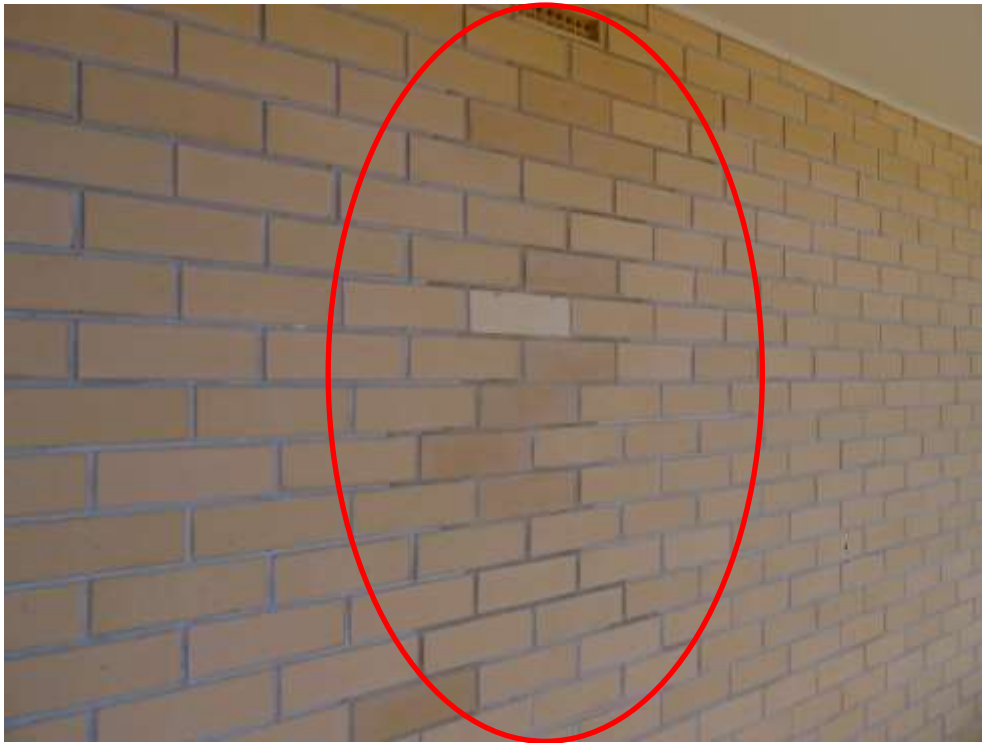
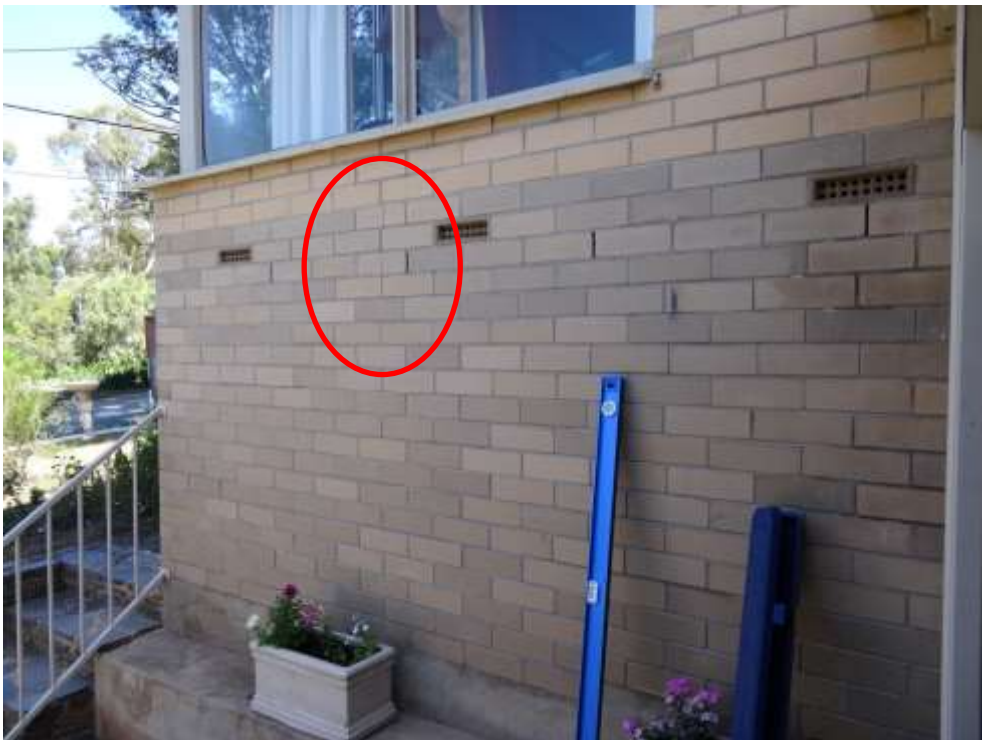
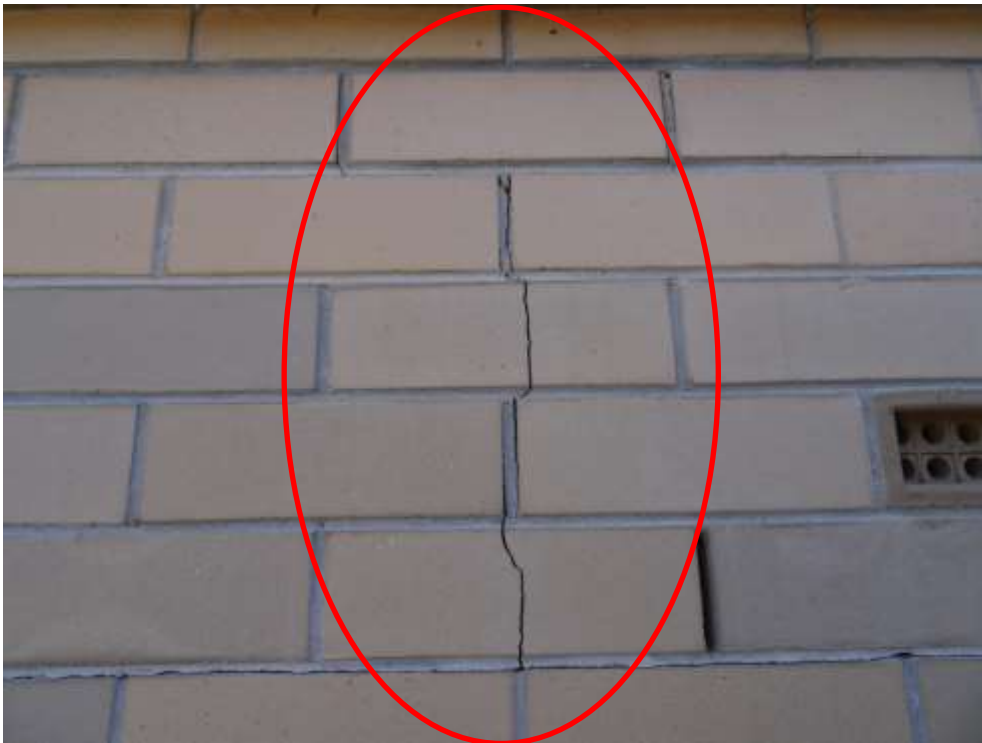
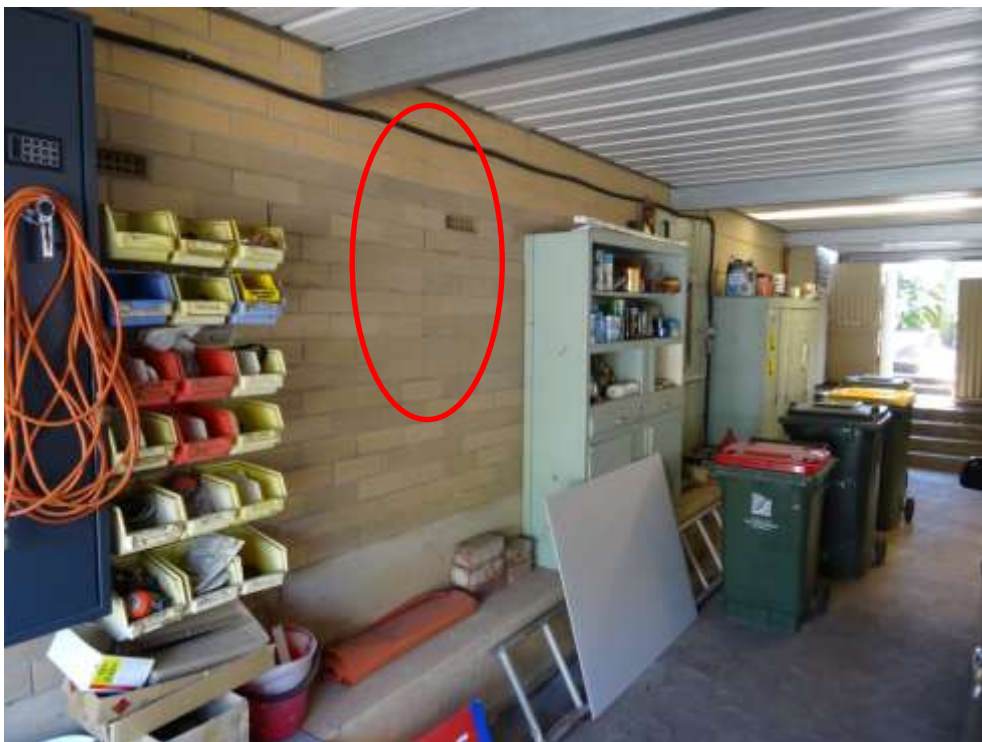
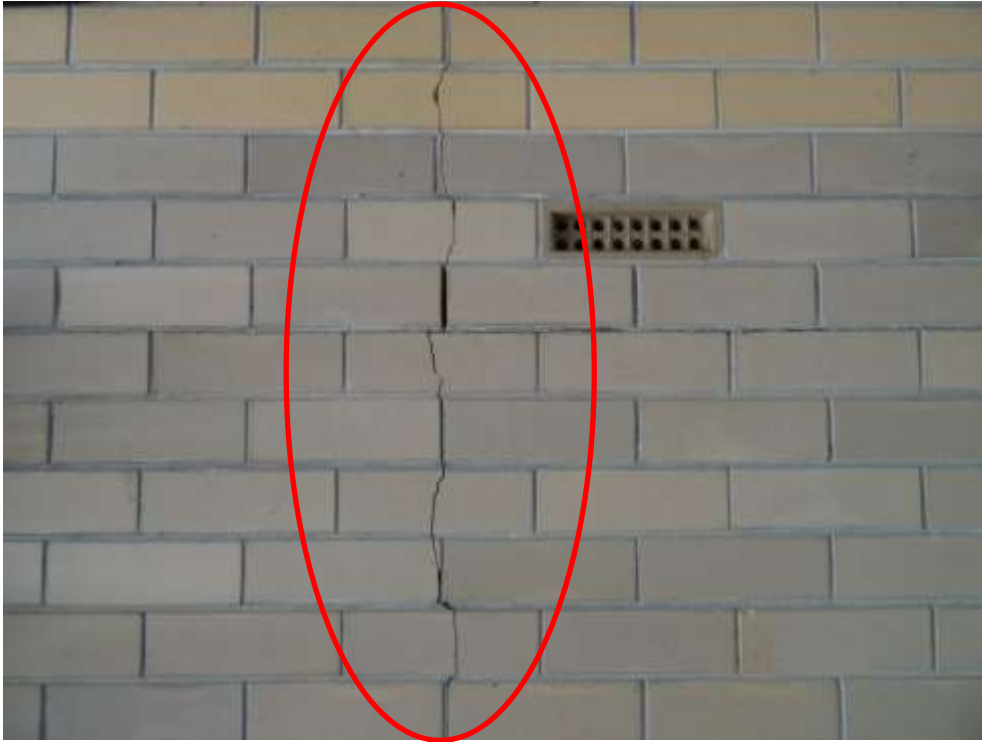
Walls: Minor Defects / Safety Hazards found : Minor cracking in brickwork as shown, can be classed as typical for age of home in area and of soil conditions. One area seems to have been repaired in what looks to be a crack.

If cracks have been identified in the table below, then A Structural Engineer is required to determine the significance of the cracking prior to a decision to purchase.

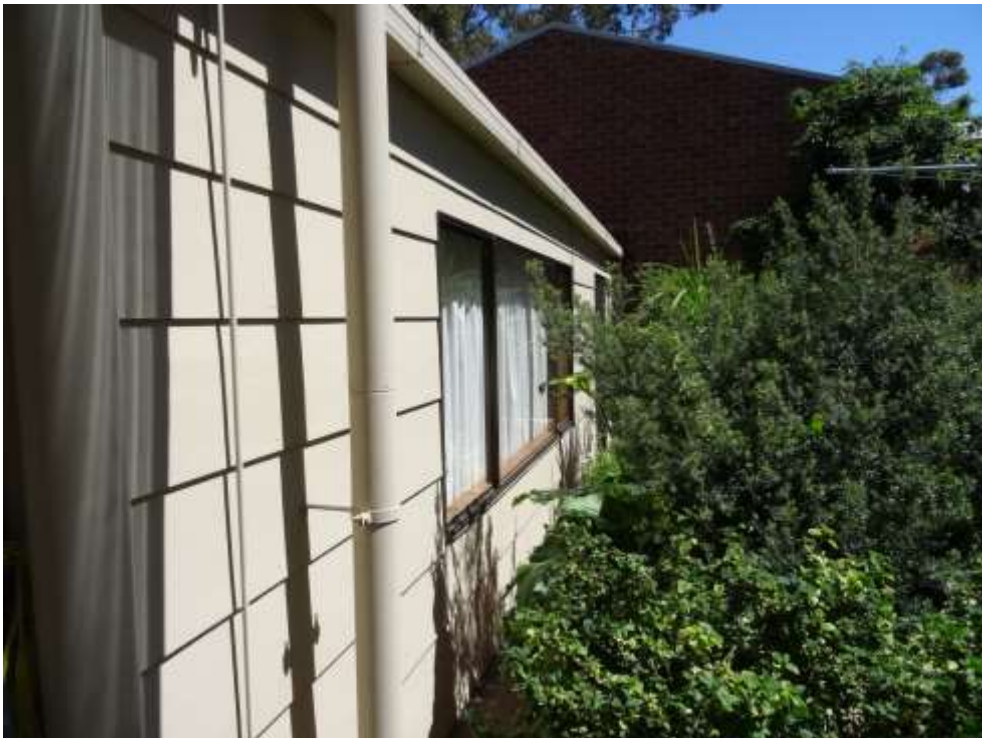
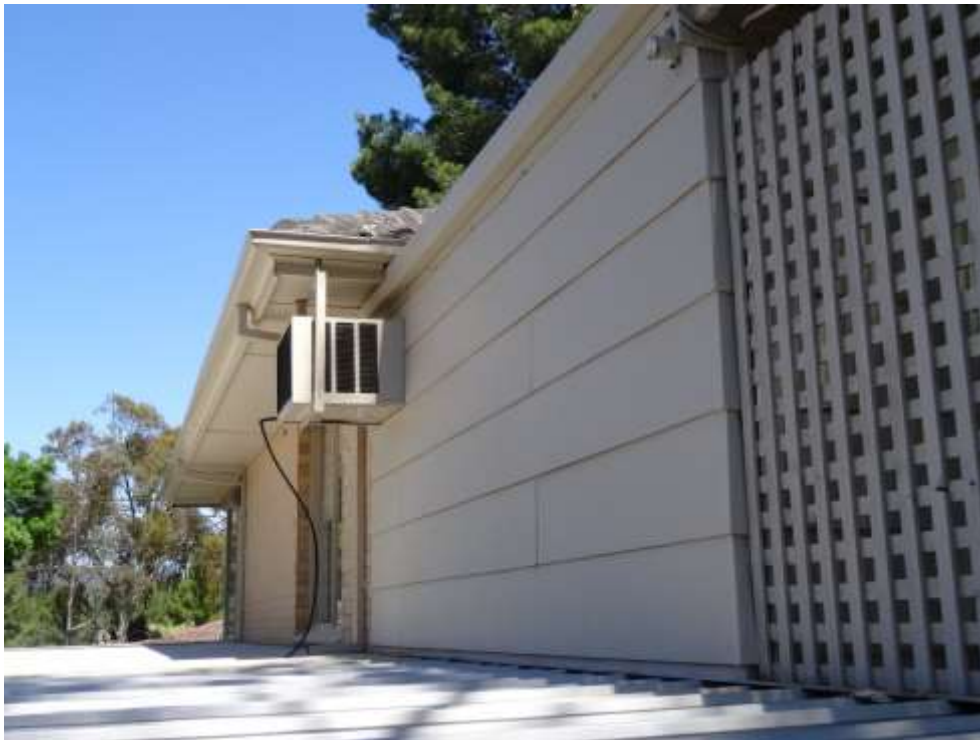
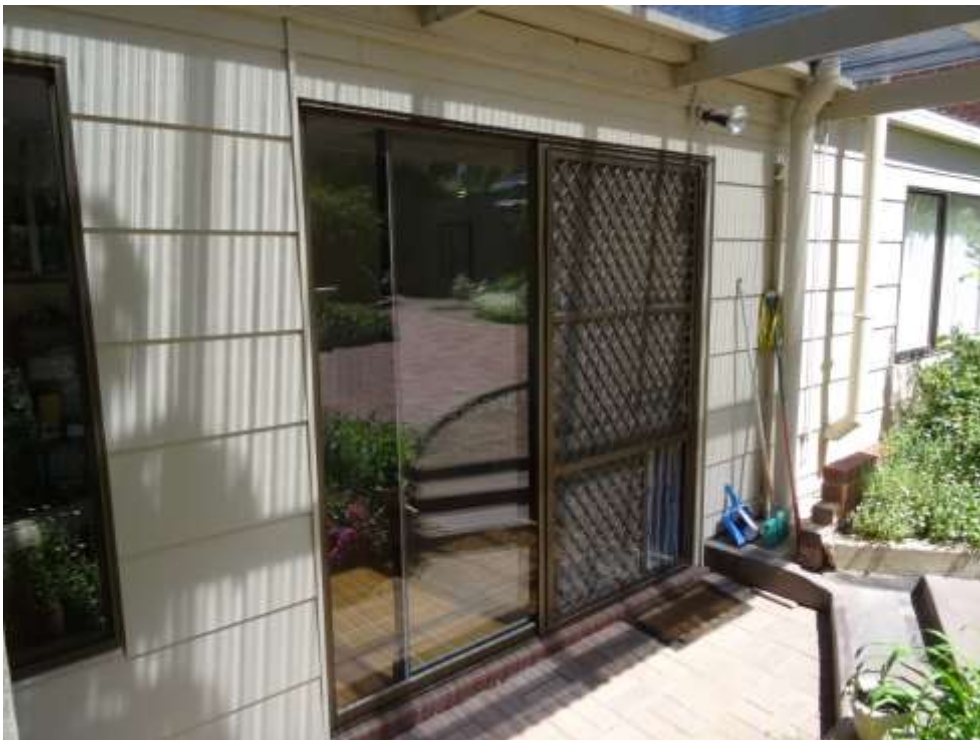
External Cladding: No Defects / Safety Hazards found : External cladding on extension at rear.

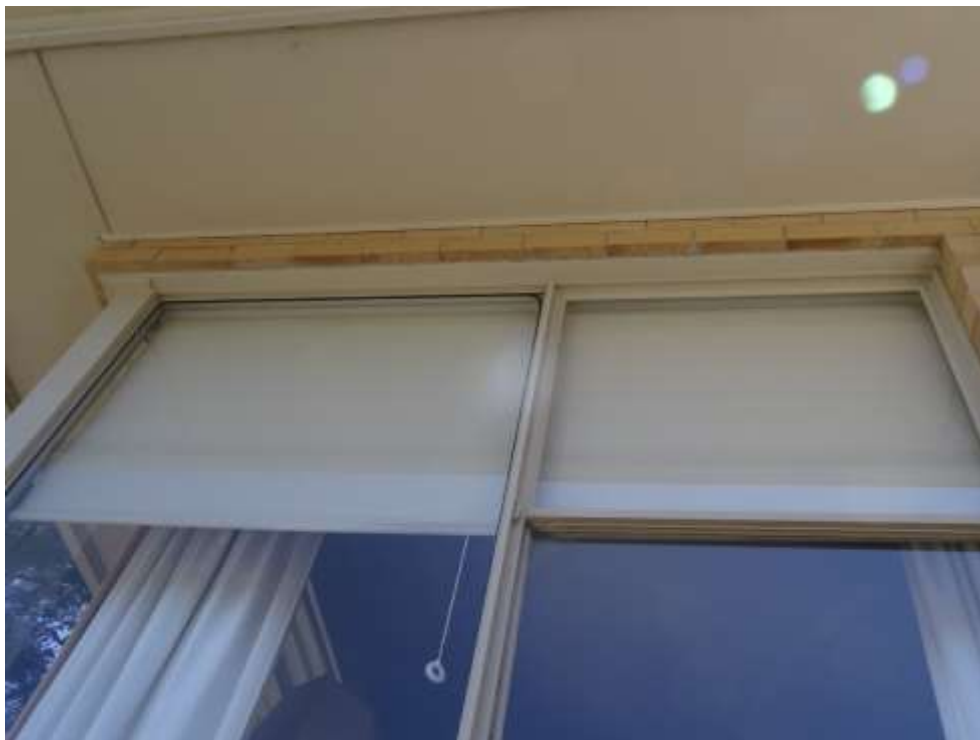
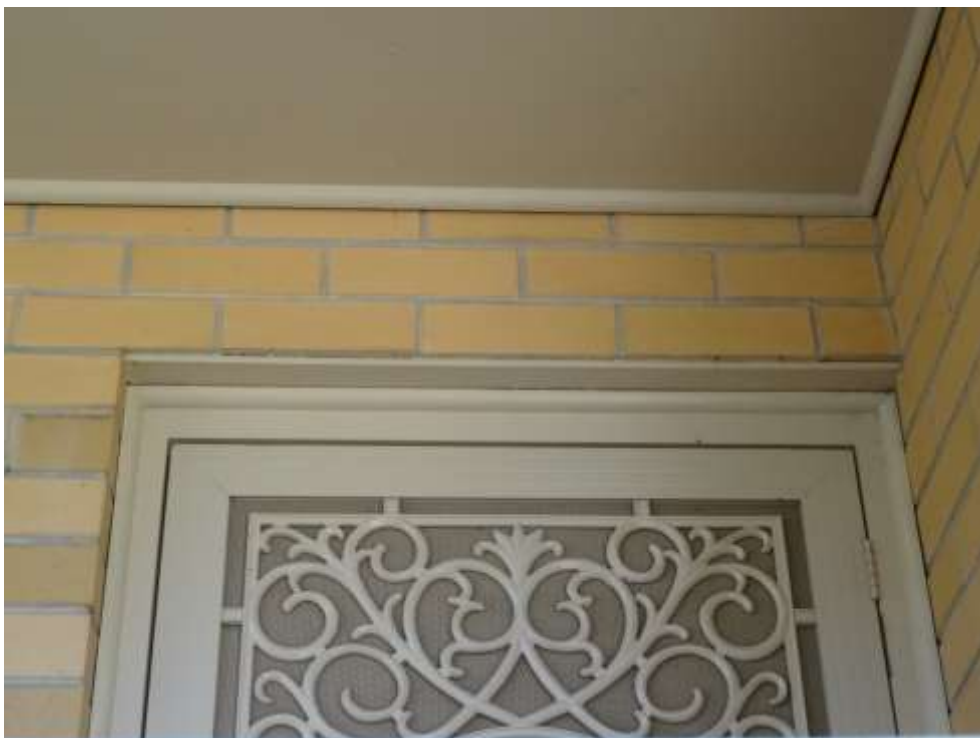
Lintels: No Defects / Safety Hazards found : Lintels in good condition

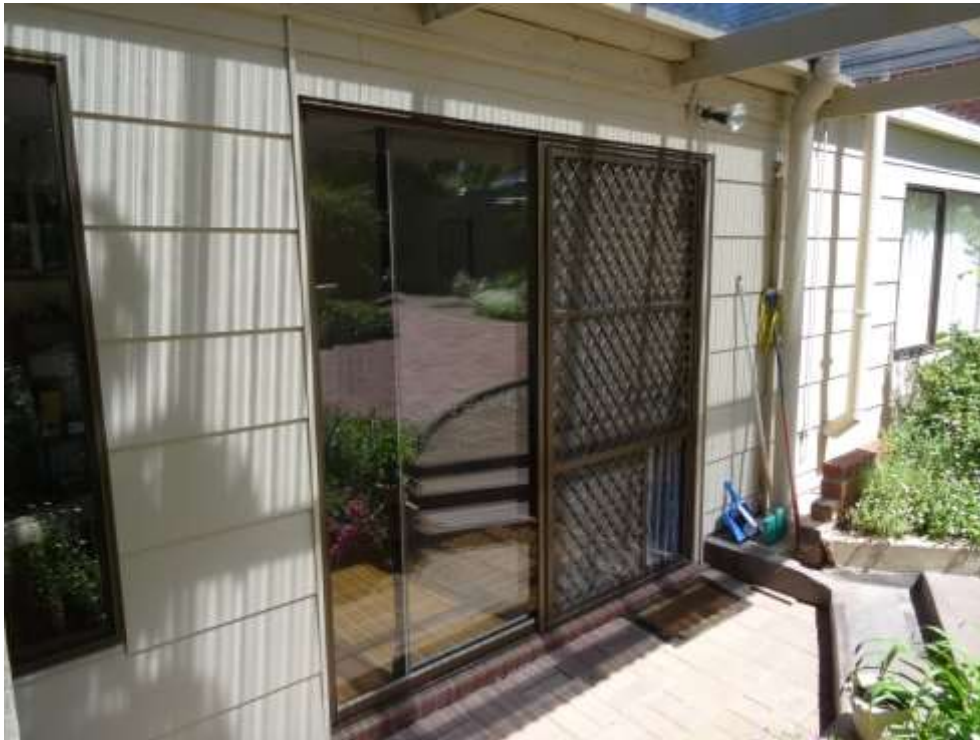
Doors: No Defects / Safety Hazards found : All doors work as designed and tested

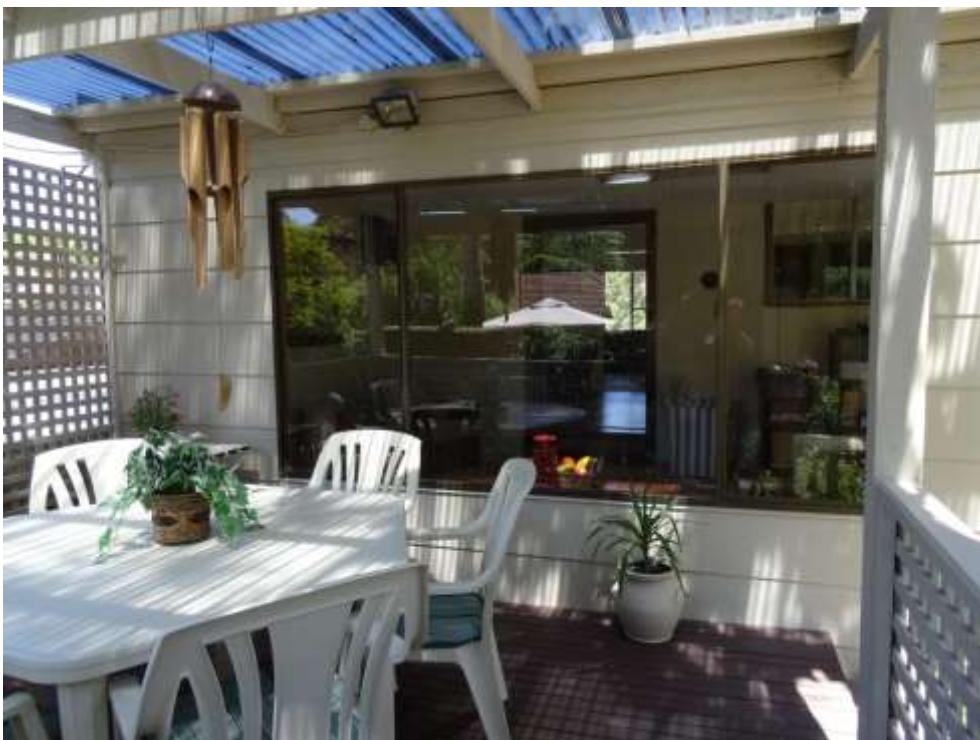
Windows: No Defects / Safety Hazards found : Windows work as tested

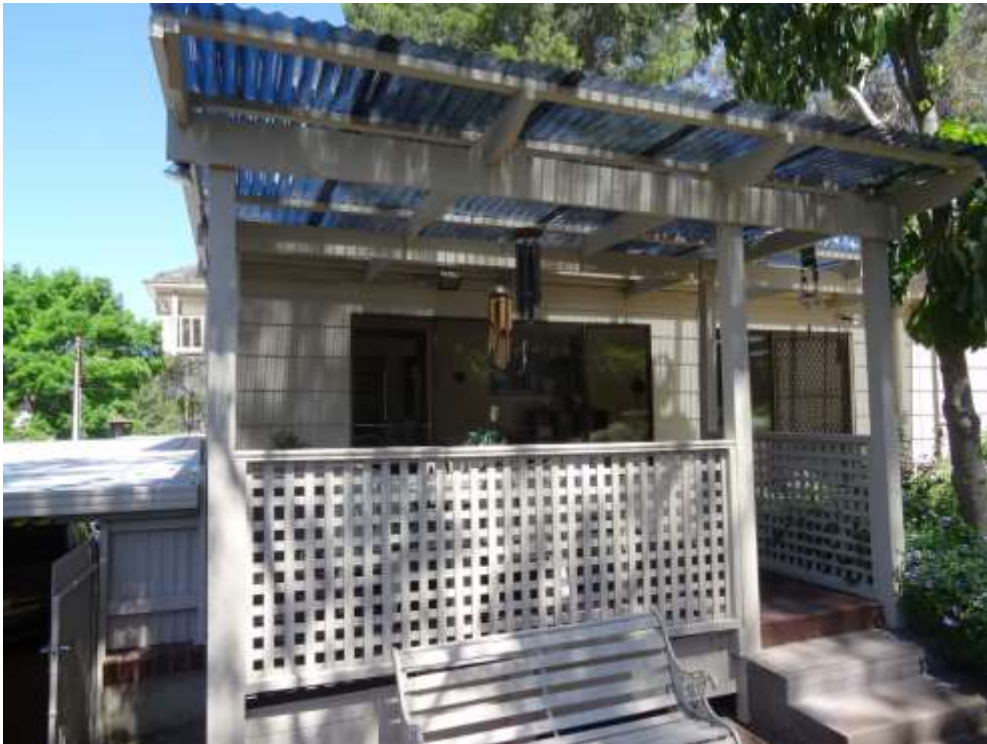
Timber and Steel Structures: No Defects / Safety Hazards found : Solid condition

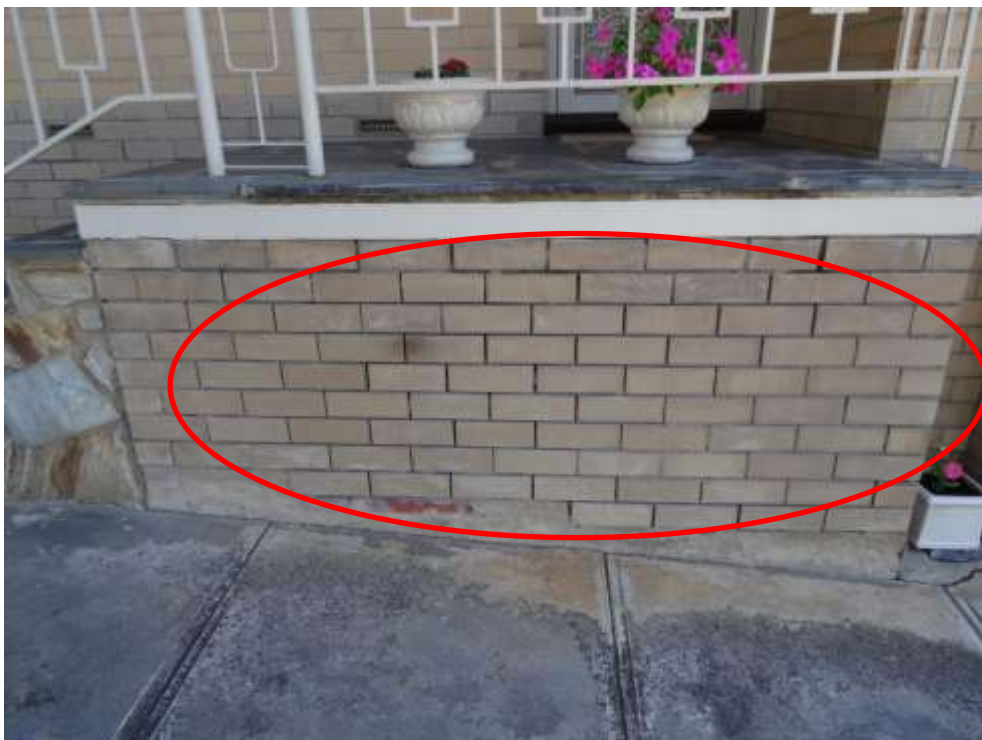
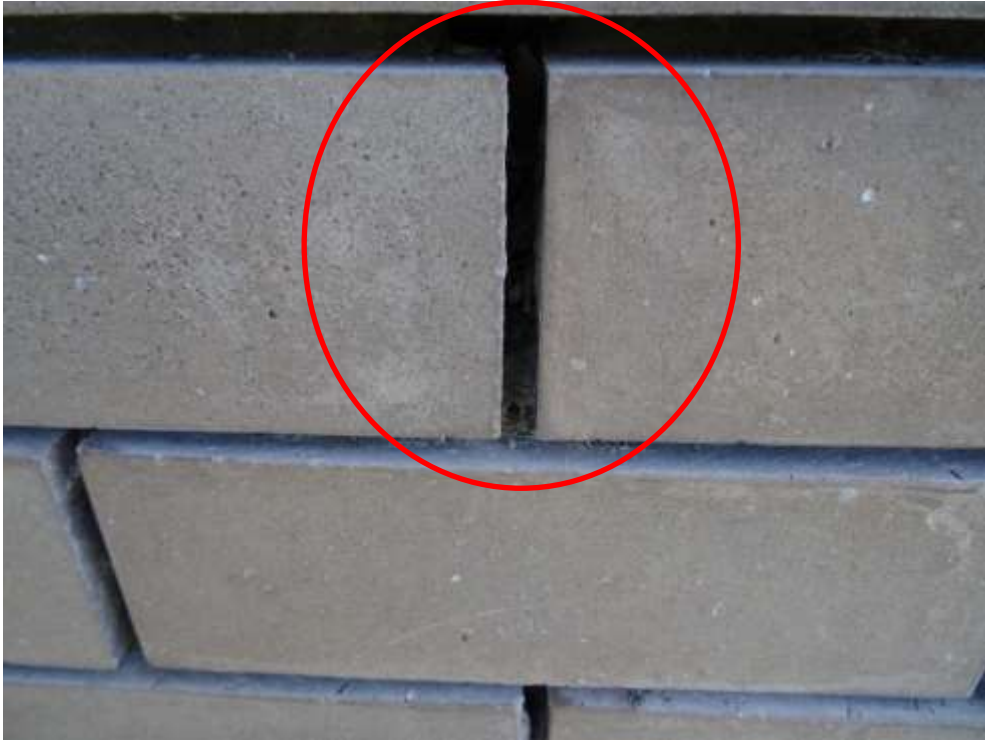
Stairs: Minor Defect / Safety Hazards found : Mortar falling out of joints on landing at front door
