Pre-Purchase Inspection - Residential Building Report

Complies with Australian Standard AS 4349.1- 2007 Inspection of Buildings Part 1: Pre-Purchase inspections – Residential buildings – Appendix “C”

Property Address: Your New Home Address

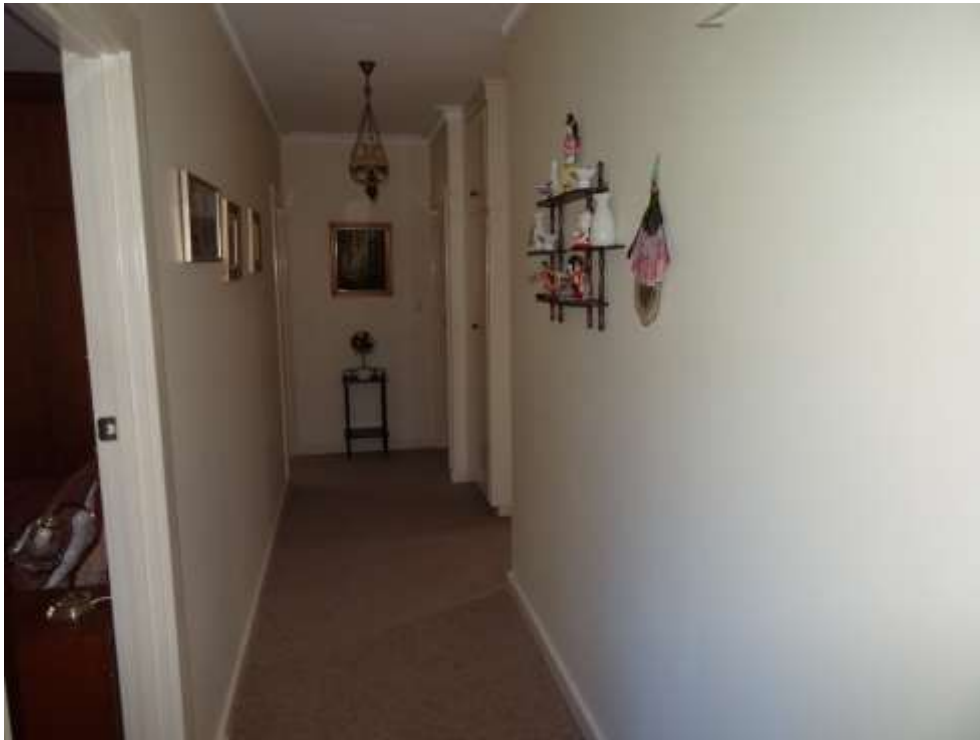
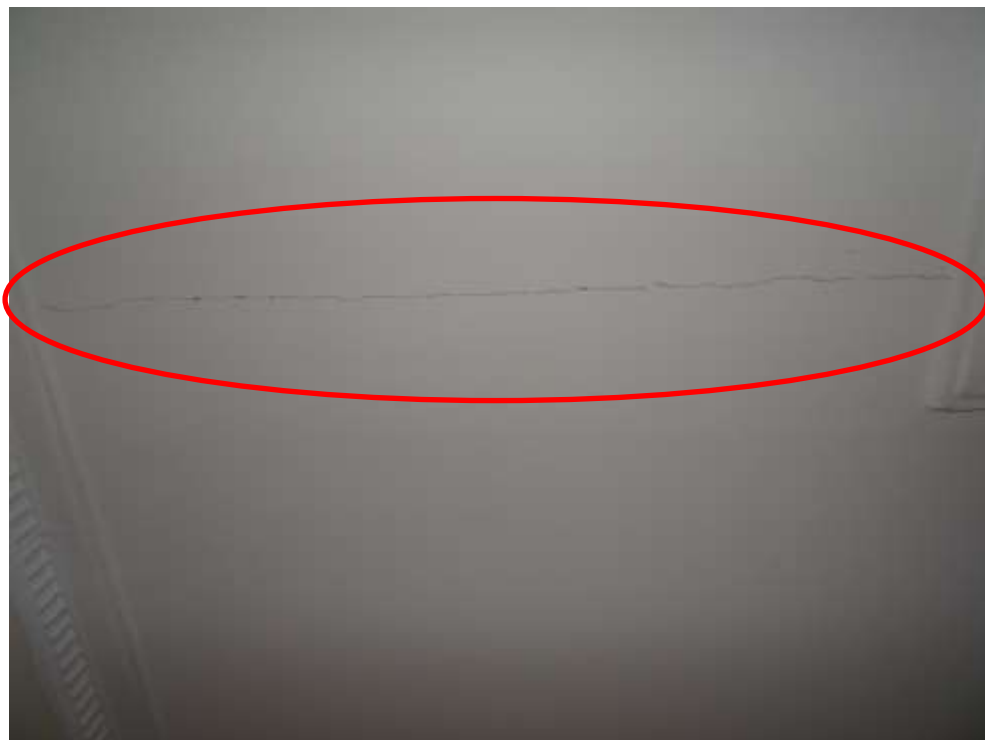
Hall: Minor Defect / Safety Hazards found : Crack in join in ceiling - Typical

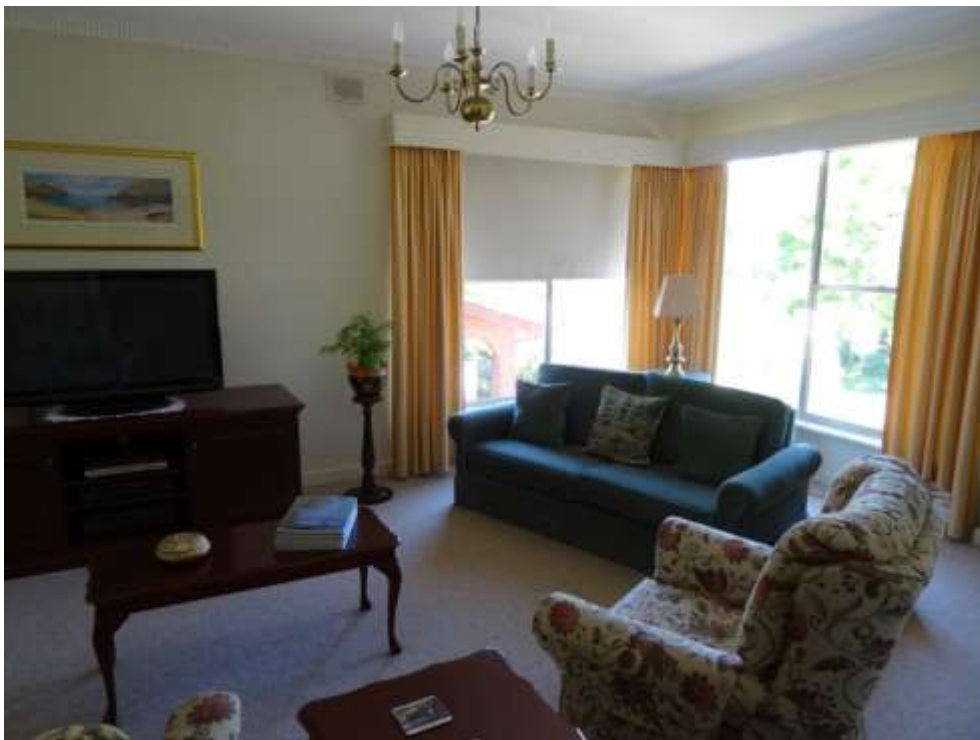
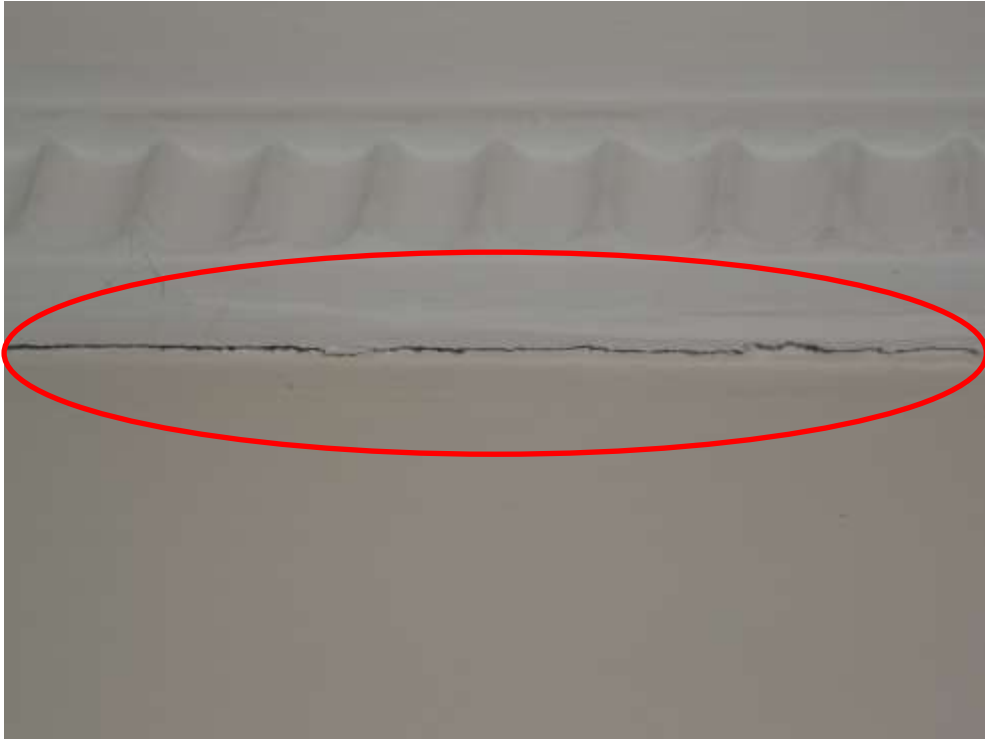
Lounge Room: No Defects / Safety Hazards found : Heater tested and works well, slight crack under cornice - Typical

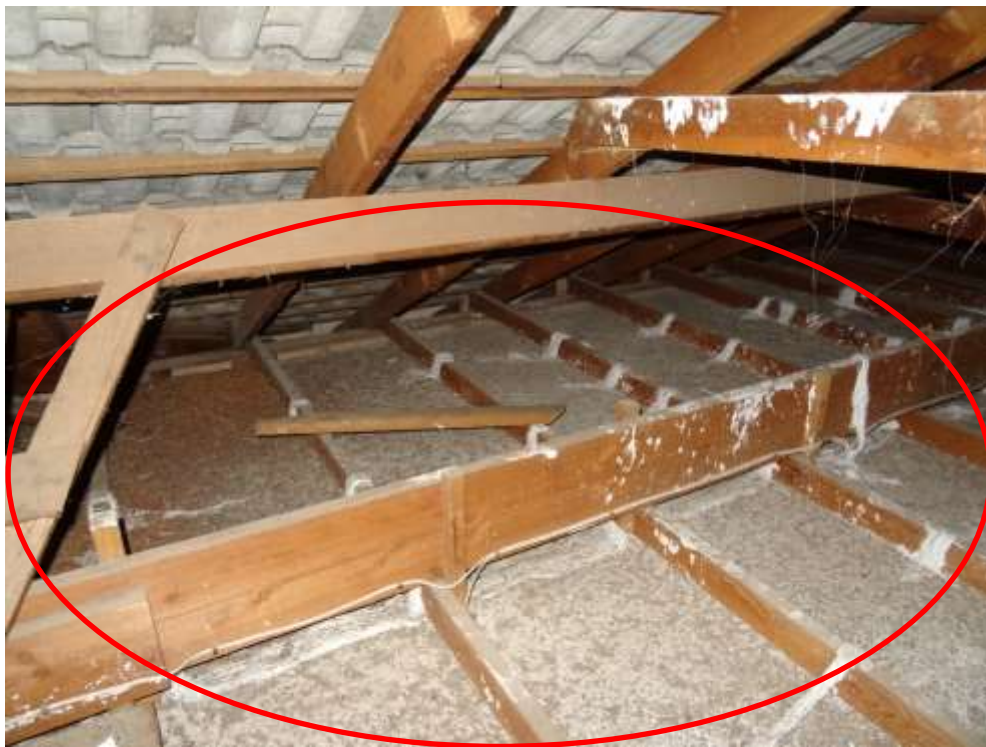
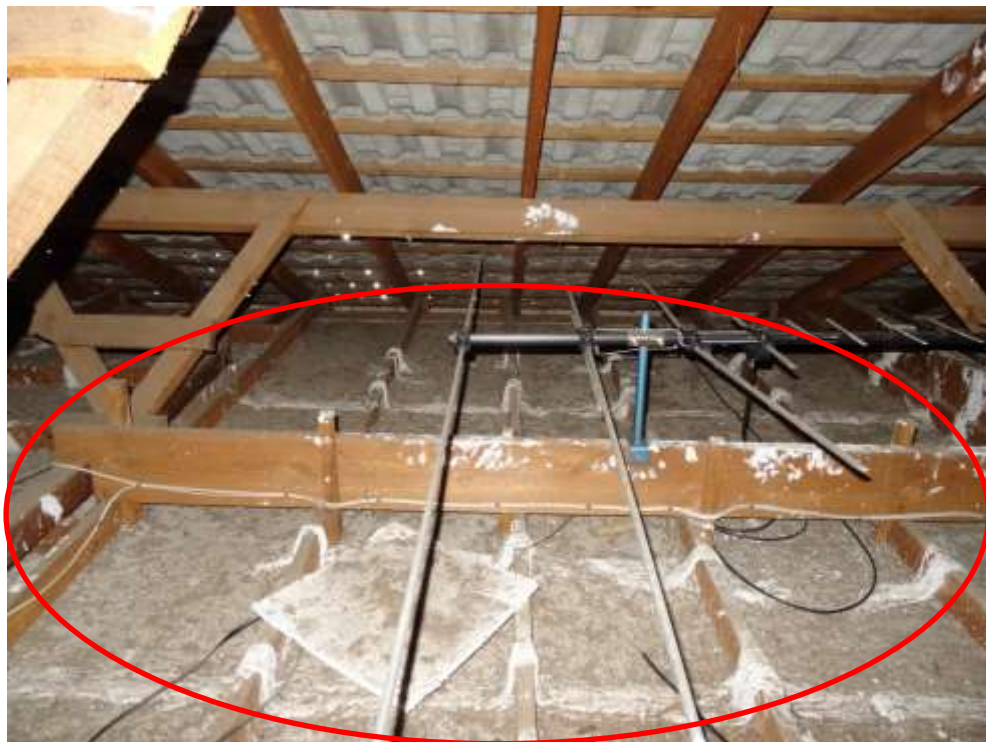
Insulation: **No Insulation Present :**

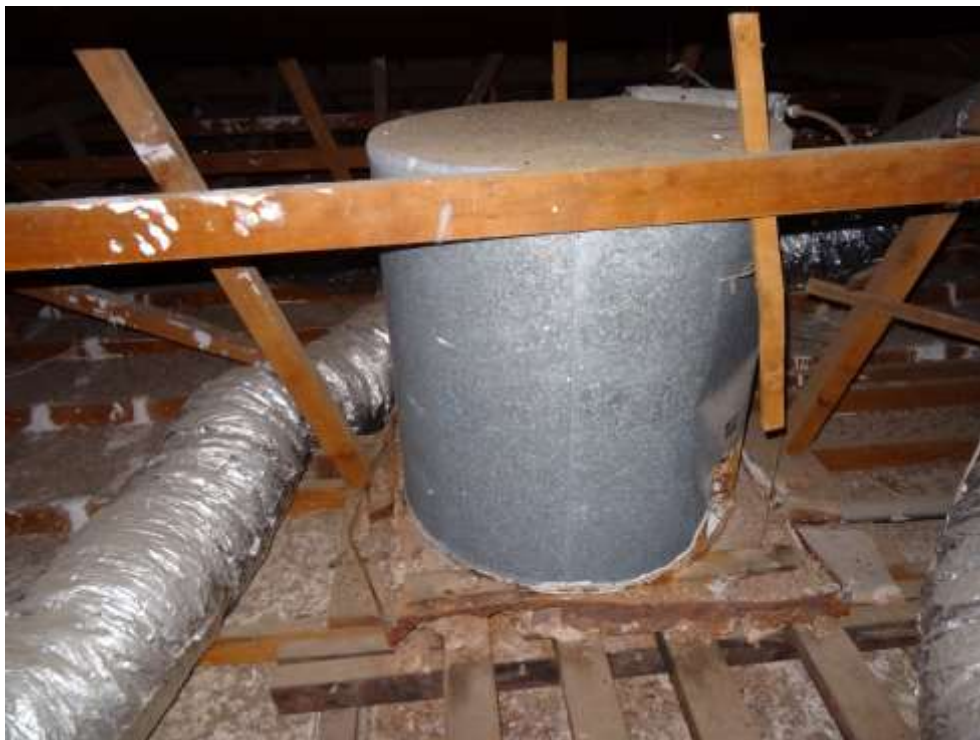
Other if Applicable: No Defects / Safety Hazards found : Old HWS in roof (empty) – Typical

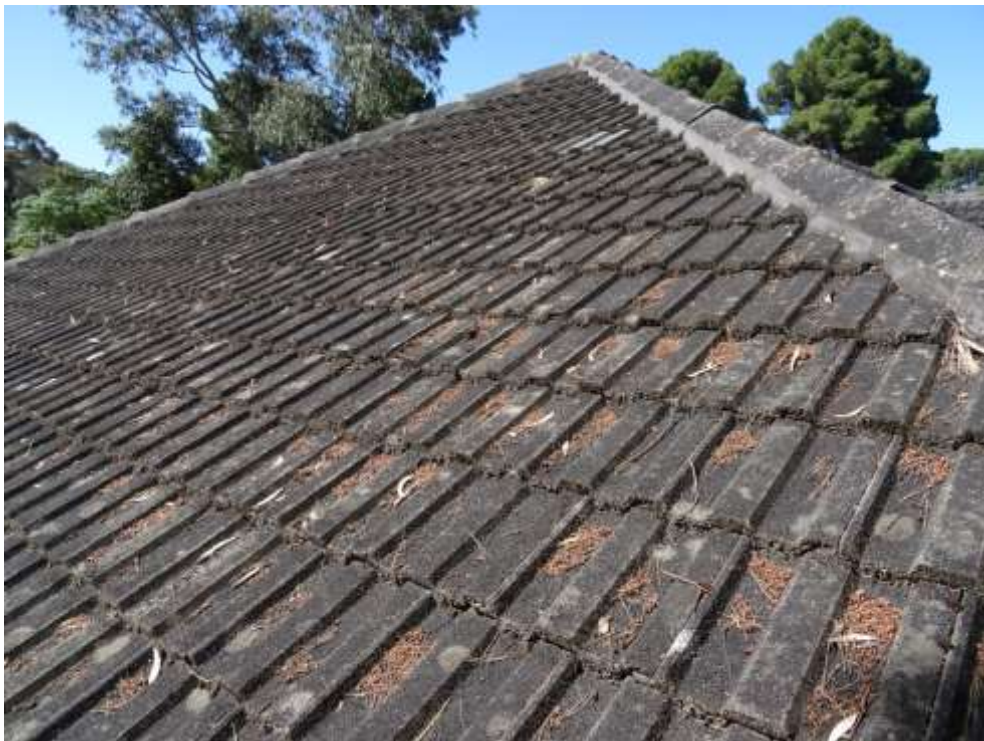
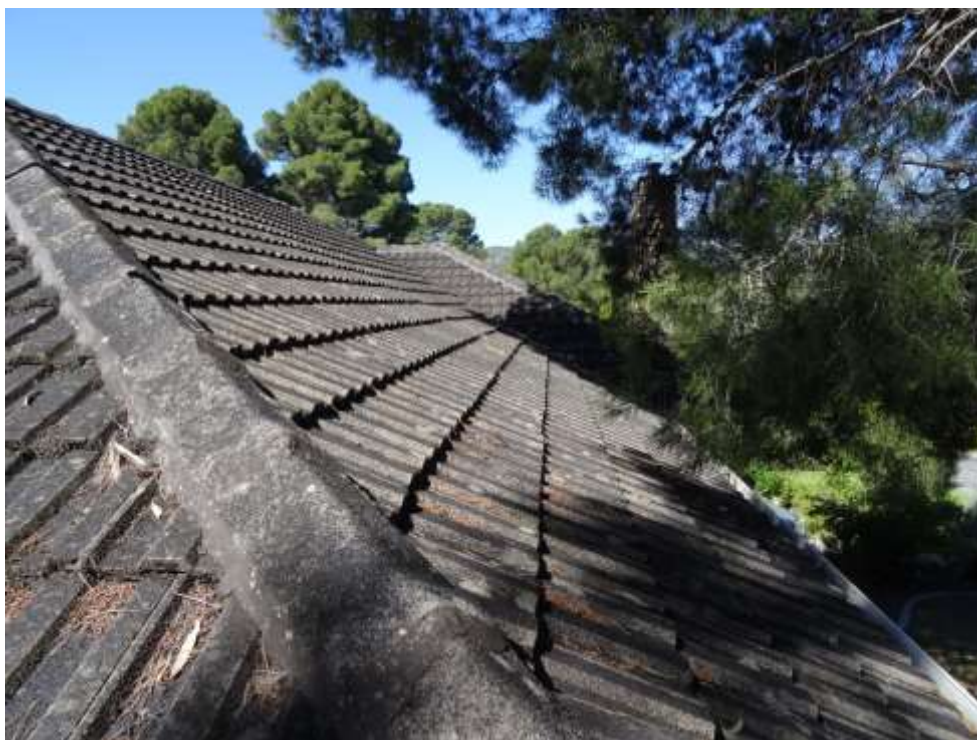
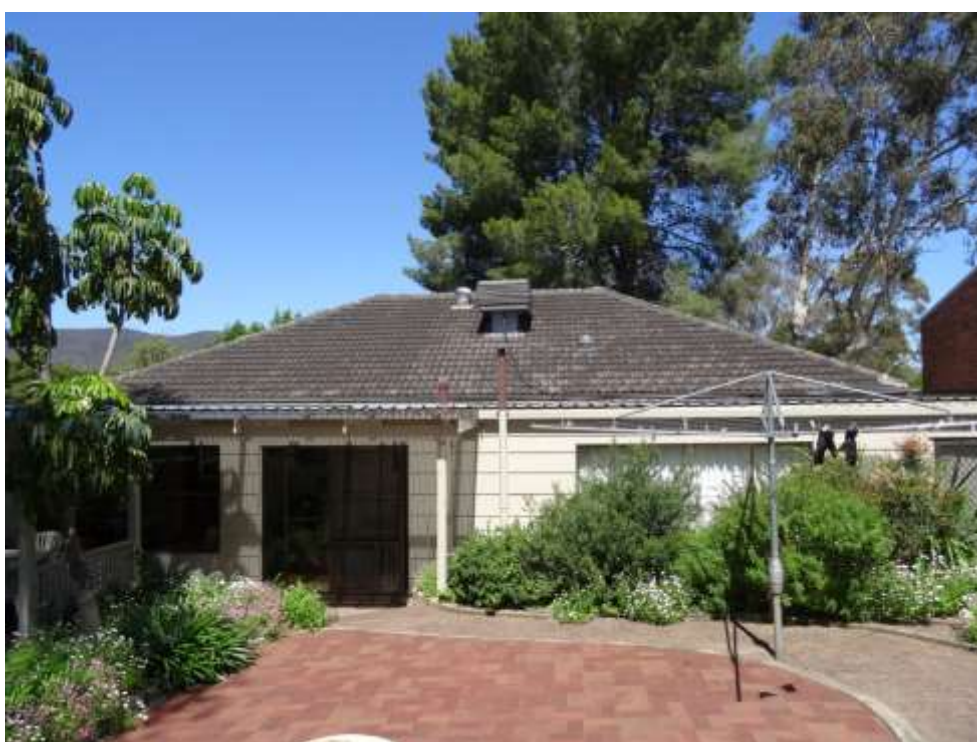
Roof Tiles: Minor Defect – Fragile and steep roof pitch, not safe to walk on. Ridge capping on ends need attention
